Reinhardt Building, 205 South Sangamon, Lincoln, 2005

Lauer Building, 201 South Sangamon, Lincoln, 2004

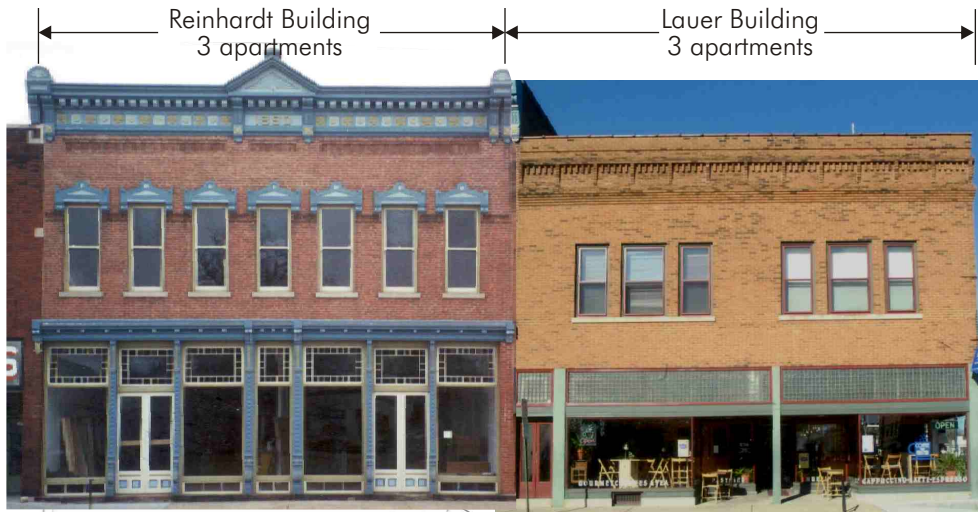
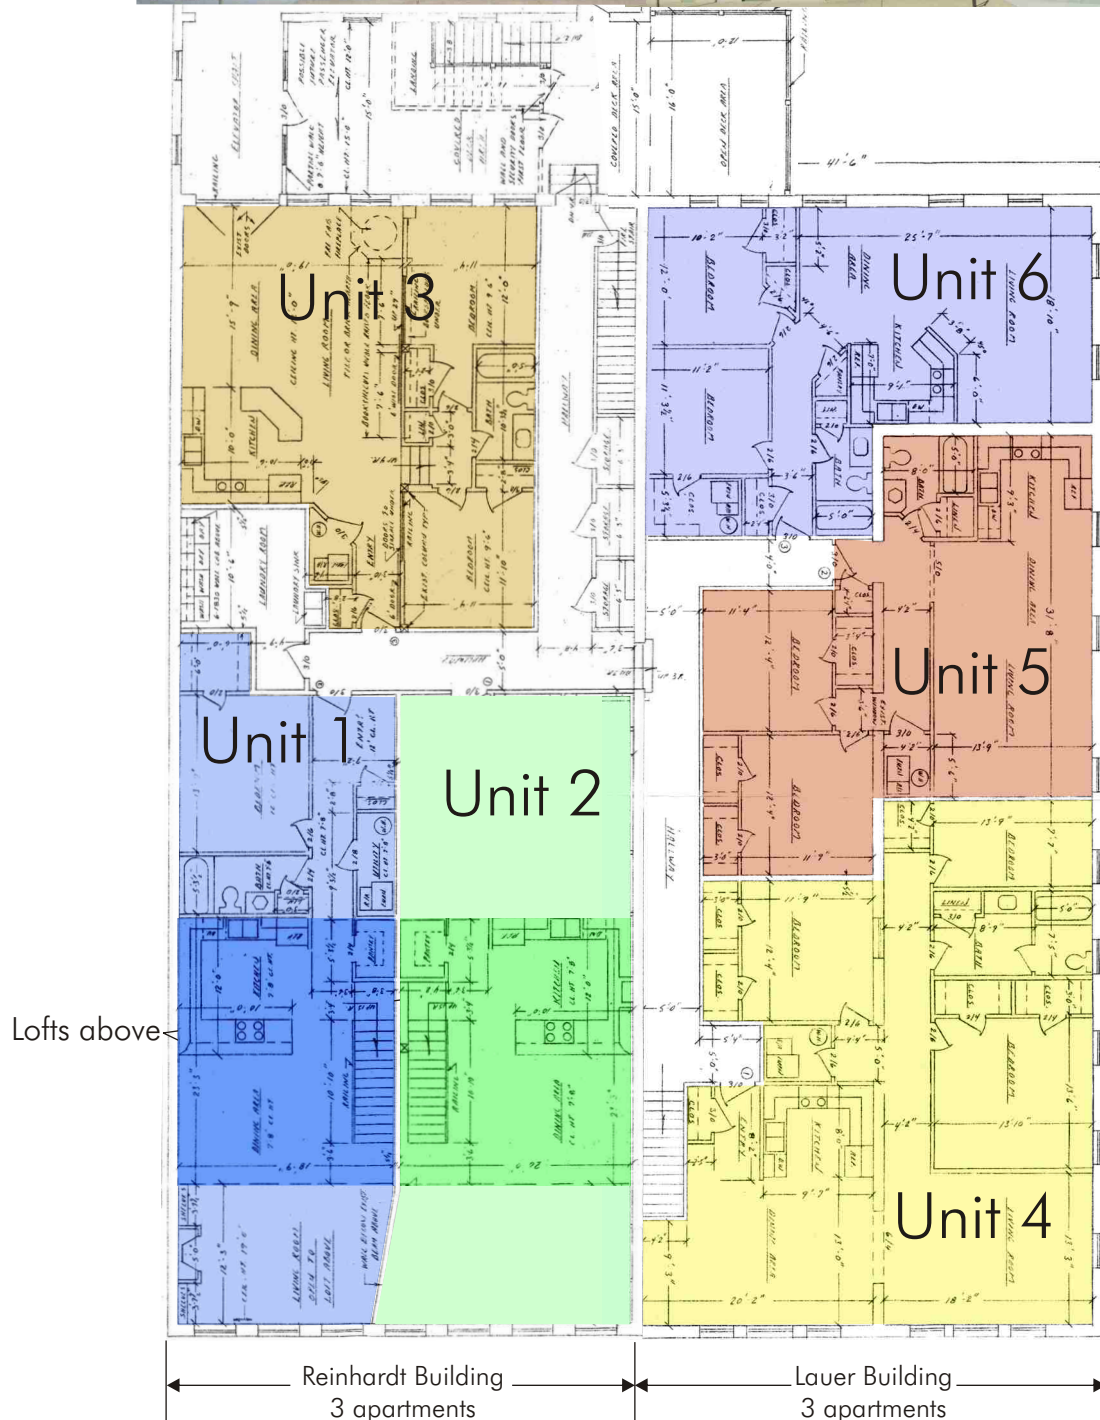
The Lauer building was itself originally two twenty-foot-wide buildings, 201 Sangamon (one story) and 203 Sangamon (a two story Italianate). The buildings were combined in 1922, the same time that they were also connected to the Reinhardt Building next door. The floor plan still shows the original brick wall that separated 201 and 203 (it runs through the centers of Units 4 and 5 between the sets of front windows).
